CONSTRUCTION CONTINGENCY PLAN IMPLEMENTATION REPORT

FORMER GAS STATION
903 9TH AVENUE NORTH
PRINCETON MN
JAVELIN PROJECT No. 2014-P0188-0090

SEPTEMBER 4, 2014

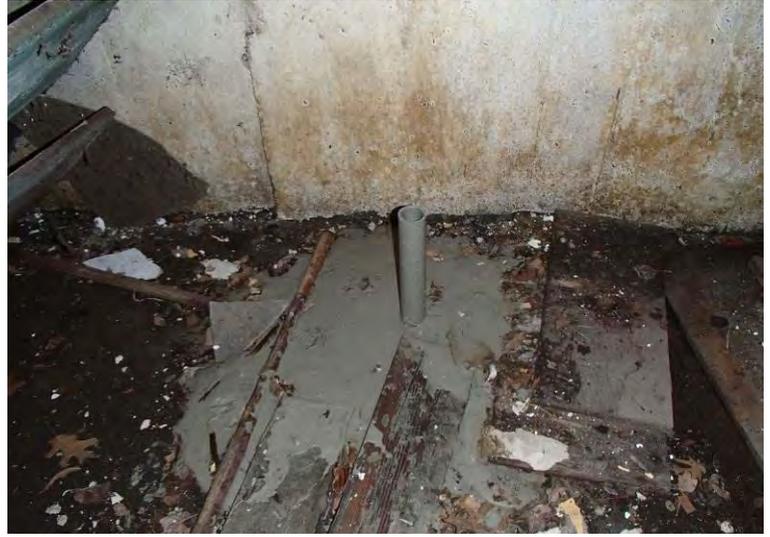
PHOTOGRAPH # 4 –
WATER WELL IN BASEMENT AFTER
GROUTING FOR ABANDONMENT

A water supply well was present in the basement of the former gas station building, near the southern corner of the building. This well was abandoned by JA McAlpine, a licensed water well contractor based in Princeton, MN, prior to building demolition. JAVELIN personnel verified the well was sealed prior to building demolition. Photographs of the well and demolition activities are included in Appendix B. The Executive Director of the Princeton Economic Development Authority, Ms. Carie Fuhrman, stopped by the site during demolition activities on August 21 to observe the progress.

- ❑ **Water Well** – A water supply well was present in the basement of the former gas station building, near the southern corner of the building. This well was abandoned by JA McAlpine, a licensed water well contractor based in Princeton, MN, prior to demolition of this portion of the building. No other water wells were encountered during the demolition.

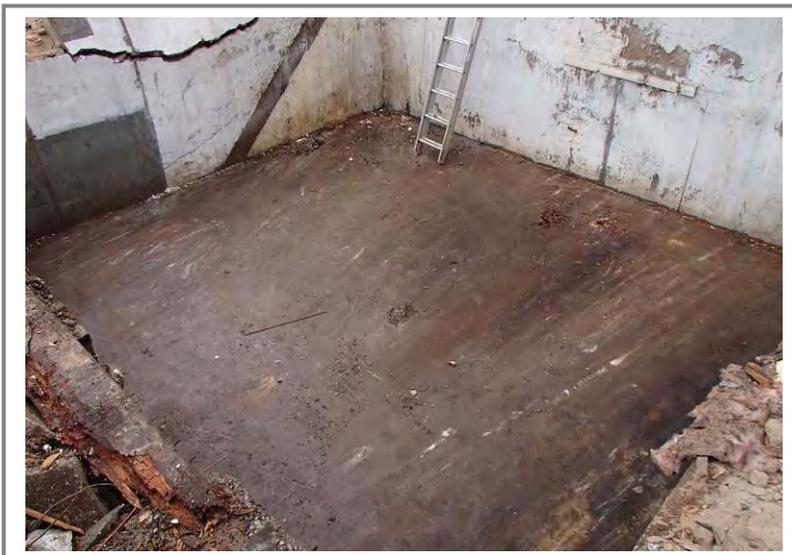
PHOTOGRAPH # 8 –
OPEN BASEMENT AFTER BUILDING
DEMOLITION

was 6" inches thick. The basement measured 26 feet in length by 21 feet in width by 7 feet 3 inches deep, with walls 8 ½ inches thick.

As work continued on removal of the concrete basement walls, West Branch personnel began hauling clean fill material to the site and stockpiling it adjacent to the building area. The basement area of the building underlaid a portion but not all of the former building, as shown on Figure 2 in Appendix A. Basement wall removal exposed soil behind the walls. A sample of soil was collected from each sidewall by JAVELIN personnel for PID headspace screening. No organic vapors were detected in the sidewall samples and no odors or staining were observed.

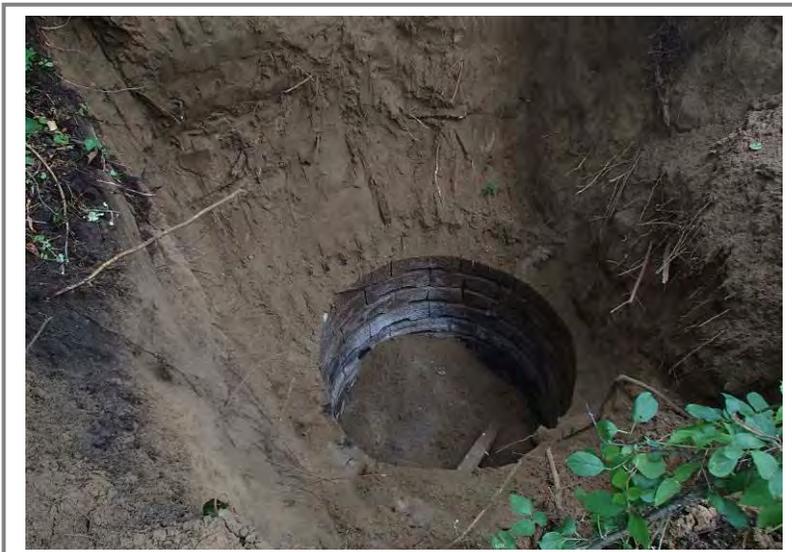
PHOTOGRAPH # 9 –
VIEW OF EXCAVATED CESSPOOL

During building demolition activities, a vertical clay pipe was observed behind the building in the area of a suspected septic tank. Excavation revealed a 4-foot deep stone block open cesspool at a depth of approximately 8 feet below grade. No stained soils or odors were noted in the excavation. The clay pipe was removed, photographs were taken, and the cesspool was backfilled with soil.

- ❑ **Septic System** – A suspected septic system was evidenced by the presence of a vertical clay pipe observed southwest of the building. Excavation revealed a 4-foot deep stone block open cesspool at a depth of approximately 8 feet below the surface. No evidence of stained soils or odors were observed in the cesspool excavation. The clay pipe was removed, photographs were taken, and the cesspool was backfilled.

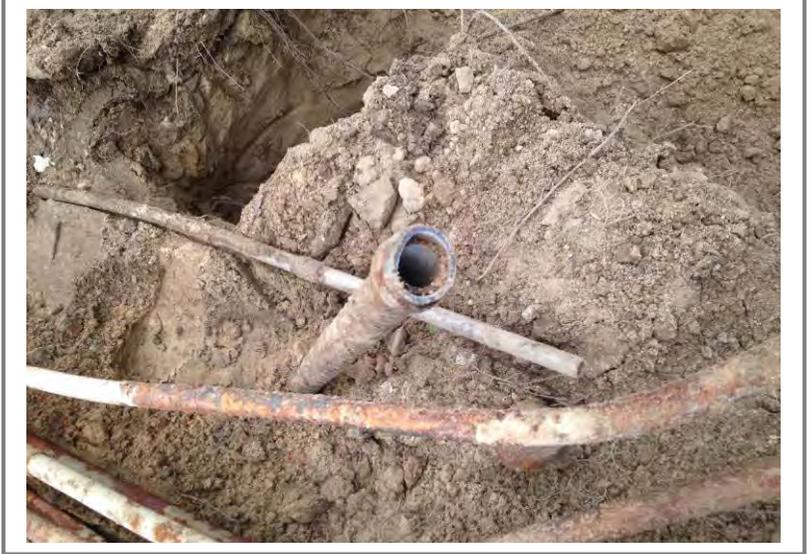
PHOTOGRAPH # 10 –
VENT PIPE OF INITIAL UST
ENCOUNTERED

During removal of the basement's northeastern wall, an underground storage tank (UST) vent pipe was encountered just off the northern corner of the building. The West Branch crew verified the presence of a buried tank using a hand probe, but did not uncover the tank. A photoionization detector (PID) equipped with a 10.6 eV lamp was used to screen the tank. A reading of 42 parts per million (ppm) was obtained in the top of the UST vent pipe, but no evidence of petroleum contamination was encountered in soils adjacent to the fill pipe.

- ❑ **USTs** - Two USTs were encountered just off the northern corner of the building. One was identified by the presence of a fill pipe and confirmed by probing, but was not uncovered. The top of a second UST was partially uncovered during site demolition activities. A PID reading of 42 ppm was obtained from the fill pipe of the first tank, and a PID reading of 0 ppm was obtained through a small hole in the top of the second tank. The sizes of the tanks were not determined, and the tanks were re-covered with soil after marking their location. No evidence of contaminated soil was observed adjacent to or overlying the tanks

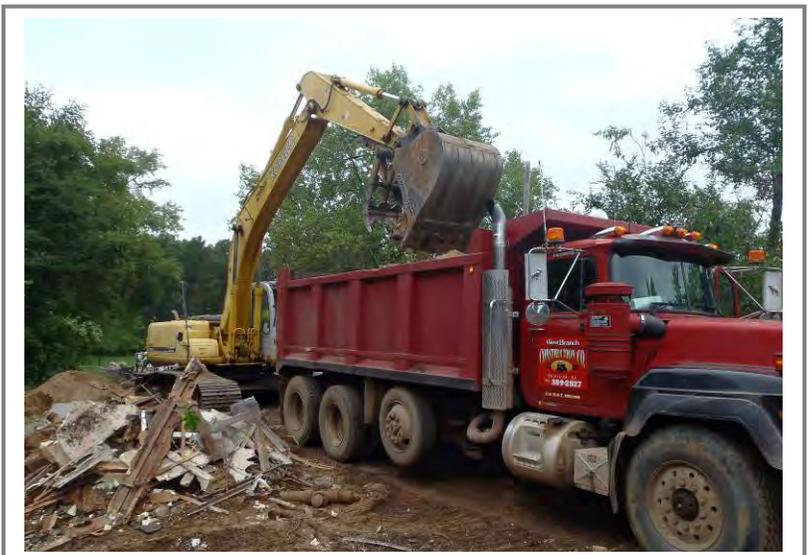
PHOTOGRAPH # 12 –
LOADING CONCRETE DEBRIS FOR
OFFSITE RECYCLING

- **Concrete** – The concrete slabs and walls of the former gas station were demolished and concrete debris was removed for recycling at Koppendrayner pit, located approximately four miles north of Princeton, Minnesota. This pit is leased by West Branch and is permitted to recycle concrete and asphalt. A total of 55.4 yd³ of concrete demolition debris was generated and hauled offsite. This includes concrete from the basement floor and walls, the first floor of the service station surrounding the basement, and the concrete slab adjacent to the building.

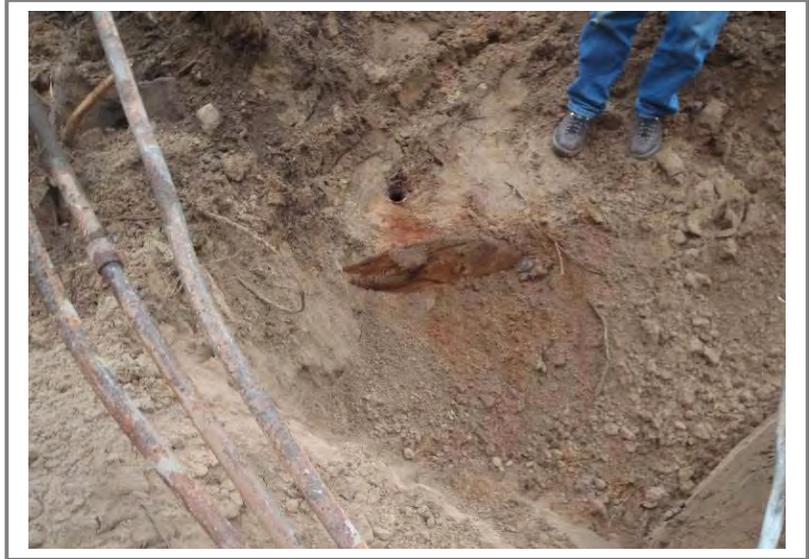
PHOTOGRAPH # 13 –
TOP OF SECOND UST ENCOUNTERED,
SHOWING SMALL HOLE IN TOP

Once the basement walls were removed, West Branch personnel began backfilling the basement and compacting it by driving over it with heavy equipment. During this timeframe, removal of the adjacent surface concrete slab began. The concrete slab was located along the northeast side of the building, in the area of the former pump island. During removal of the slab, a second UST was encountered adjacent to the first one. The top of one end of the tank was exposed and revealed a small hole in the top of the tank. A PID reading of 0.0 ppm was obtained by JAVELIN personnel through the top of the tank.

- ❑ A licensed tank removal contractor should be retained by the City of Princeton to excavate and remove the two USTs from the site. Confirmation soil sampling will be required at that time per MPCA regulations, to determine whether or not there is any soil contamination adjacent to or beneath the tanks.
- ❑ If soil contamination is detected, a release should be reported to the Minnesota State Duty Officer by calling 1-800-422-0798.
- ❑ Records of disposal of the demolition debris at the Vonco Landfill should be retained by the City of Princeton.

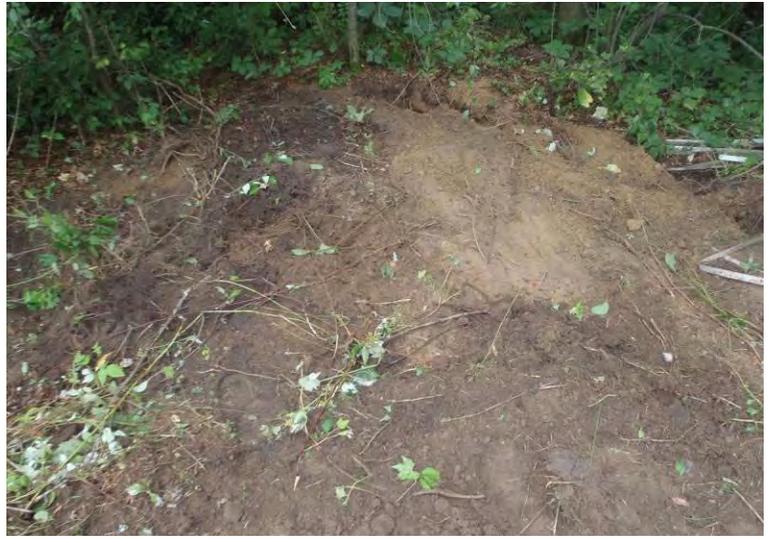
PHOTOGRAPH # 16 –
VIEW OF CESSPOOL AREA AFTER
BACKFILLING

A water well located in the basement of the former gas station was abandoned prior to demolition activities. A suspected septic system was determined to be a vertical clay pipe leading to a 4-foot deep stone block cesspool buried 8 feet beneath the surface. No contamination was observed, and after removing the clay pipe the cesspool was backfilled.

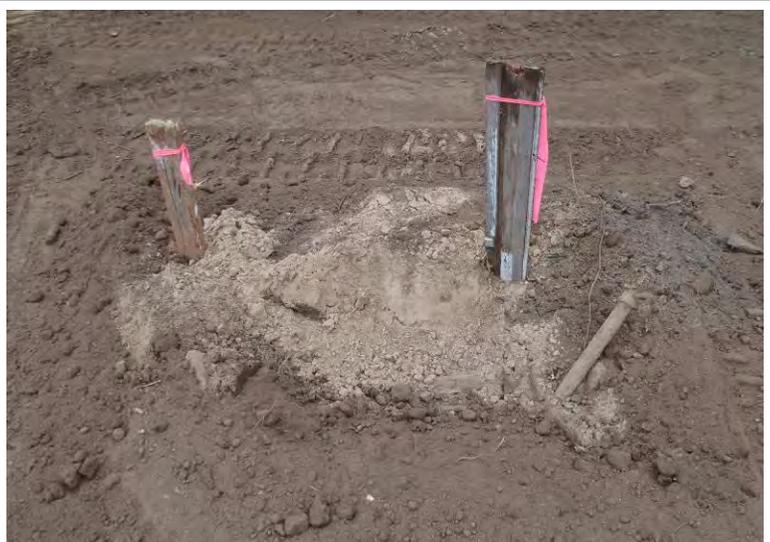
PHOTOGRAPH # 18 –
MARKING OF BURIED UST'S
REMAINING AT SITE

Ms. Carie Fuhrman was notified by JAVELIN following the discovery of each UST. JAVELIN personnel recommended that a licensed tank removal contractor be contracted to remove the tanks, as West Branch is not a licensed UST removal contractor. The USTs were left in place and re-covered with soil. The locations of the tanks were marked with a vertical 2x4 left in place along the south side of each tank. Once the basement was mostly filled with clean backfill soil, work was stopped for the day.
